Manhole Inspection Summary

Manhole # S15E__004MH

Insp Date: **10/5/07 11:03 AM**

Location Address: **241 FRANKLINTOWN RD** Cross Street: **FRANKLIN ST**

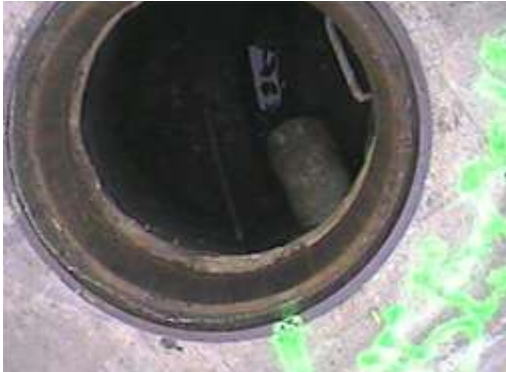
Defect 1

Frame Offset: **1** (in.) Condition: ☒ Sound ☐ Cracked ☐ Leaks

OFFSET FRAME

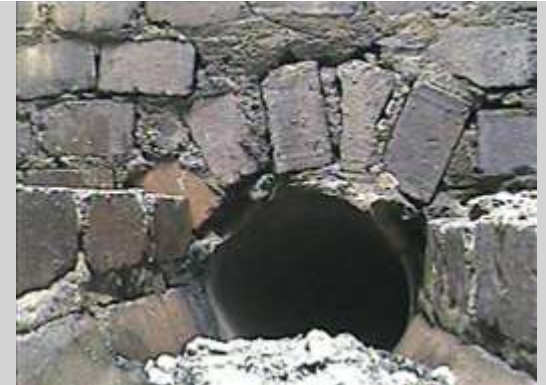
12 O'Clock Outflow

8 in. Circular Gravity Sewer
Pipe Out @ 12 O'Clock

Pipe Height: (in.) Direct
Pipe Material: **Clay** ☐ Pipe Lined
Invert Depth: **6.63** (ft.) Flow Characteristics: **Slow**
Deposits: ☐ None ☐ Mud ☐ Sludge ☒ **Debris** ☐ Grease
Silt Depth: **1** (in.) Deposits Extent: **Light**
Infiltration: **None** Pipe Seal Cond: **Cracked**

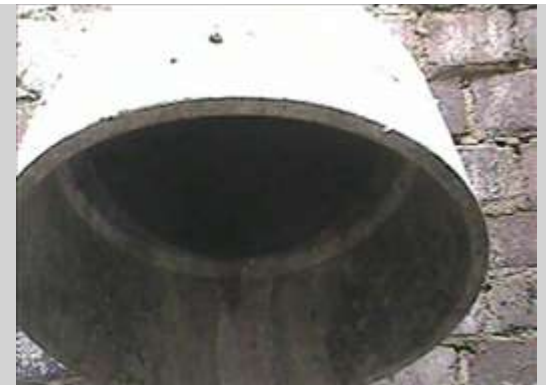
6 O'Clock Inflow

8 in. Circular Gravity Sewer
Pipe In @ 6 O'Clock

Pipe Height: (in.) Direct
Pipe Material: **Clay** ☐ Pipe Lined
Invert Depth: **4.40** (ft.) Flow Characteristics: **Slow**
Deposits: ☐ None ☐ Mud ☐ Sludge ☒ **Debris** ☐ Grease
Silt Depth: **1** (in.) Deposits Extent: **Light**
Infiltration: **None** Pipe Seal Cond: **Sound**

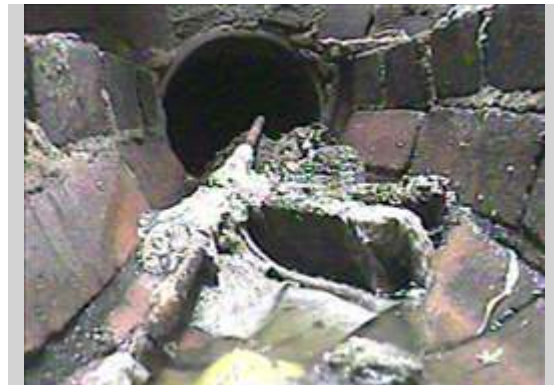
Drop In @ 6 O'Clock

Drop: **Outside Direct**
Angled: Reading: (ft.)
Inv Depth: **6.54** (ft.)

Drop Condition: **Open**
